AP4040
PROFESSIONAL SERIES

MODEL TYPE: YS4040

SERVICE MANUAL

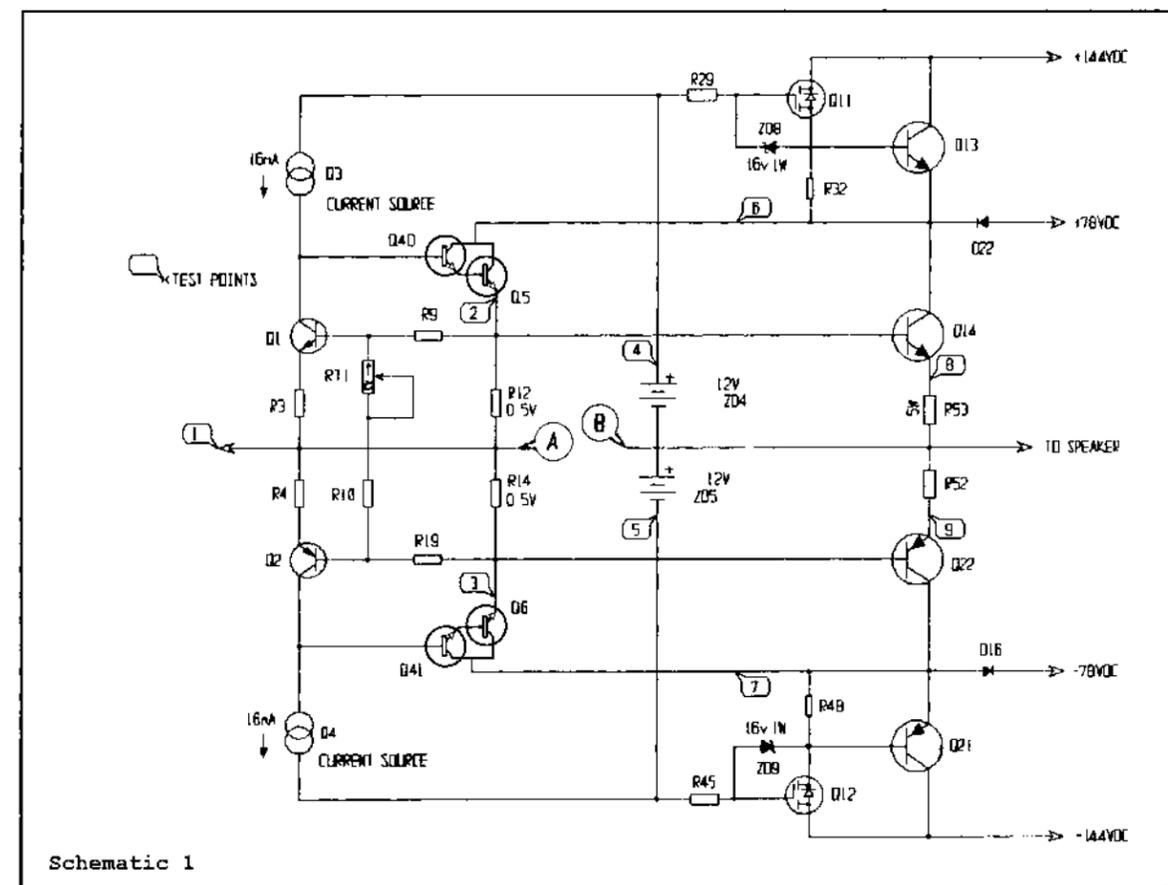
Schematic 1

[CIRCUIT DESCRIPTION - REFER TO THE SIMPLIFIED SCHEMATIC #1 ON THE FOLLOWING PAGE]

QUIESCENT CONDITION:

This causes Q40 to turn off until the reduced current flowing through Q5 maintains 0.5V across R12. Q1 will turn off slightly causing Q5 and Q40 to increase their collector currents. The circuit reaches a point of equilibrium with approximately 0.5V across R12.

Because all output devices are not identical and base emitter voltages vary, some adjustment must be available to slightly adjust the 0.5V across R12. This is accomplished with RT1. RT1 causes Q1 to turn on slightly more or less resulting in Q5 and Q40 turning on slightly more or less and therefore R12's voltage will be slightly more or less than 0.5v. The proper quiescent current voltage is 4mV (to be measured between test points 8 and 9).

Refer to the simplified schematic Fig. #1 while reading the following text. One way of making an amplifier more efficient is to vary the Power Supply Voltage on the collectors of the output transistors (Q14 & Q22). The lower the voltage from collector to emitter, the lower the device dissipation. During quiescent conditions, there is 55VDC on the collectors of output transistors Q14 and Q22. The peak AC voltage that can appear on the amplifier's output is approximately 139V peak. How can an output transistor deliver a 139V peak when its collector is only at 78VDC? It can if its collector is pulled up to 144VDC as the output signal's peak rises above 78VDC. Refer to Fig. #2. The second tier voltage must remain above the amplifier's output voltage by amount V_m . Therefore the circuitry controlling the second tier voltage must increase the tier voltage before the amplifier's output voltage reaches 78VDC. This leading voltage is necessary to compensate for time lag of the second tier circuit during fast rising amplifier output signals.

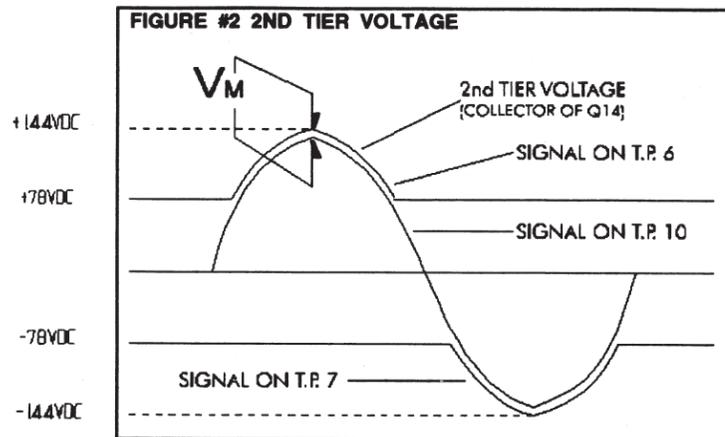
The voltage between the amplifier's output and test point 4 is approximately 12VDC derived from the voltage drop across ZD4. We call this voltage the "floating battery" because it floats on top of the output audio signal with test point 4 always being 12VDC greater than the peak of the output signal. Test point 4 drives the gate of mos-fet Q11. Q11 controls the transistors of the upper tier. As Q11 turns on its source forward biases the base of Q13 and Q13 pulls the collector of Q14 towards the 100 volt rail. The gate to source voltage needed to turn on Q11 is approximately 3.5 volts. When the peak output signal is about 69.5vp (78v-(12v-3.5v)) then Q11 will start to turn on the second tier. The second tier voltage will remain about 13 volts (V_m) above the peak of the output signal

to the point of clipping where this voltage is reduced to about 6 volts (measured driving an 8 ohm load). Zener ZD8 protects the gate source junction of Q11 and also provides a supply current path through R29 for the "floating battery".

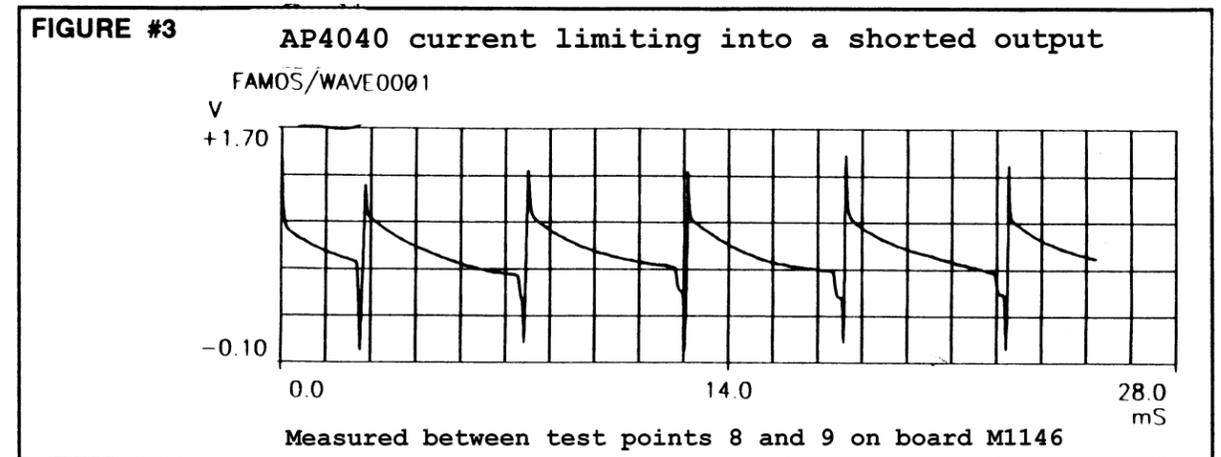
FREQUENCY: 100Hz Y SCALE: 1 VOLT = 10 AMPS

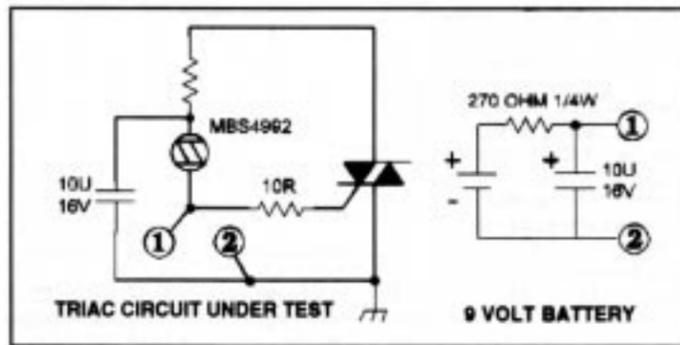
NOTE: Every time you replace blown output transistors on a M1146 board test the DC protection triac with the following circuit.

Conditions of test:

- A) Pass a 100Hz 25v peak signal through the M1126 board under test with no load connected to the amplifier output.
- B) Connect points 1 and 2 as shown in the diagram. The amplifier should go into protect mode as the triac (if working) shorted the output of the amplifier to ground, and the amplifier goes into current limit.
- C) Disconnect the triac test circuit and allow the amplifier to complete it's protect cycle.
- D) Reverse connections 1 to 2 and 2 to 1 and test again. The same results as in B) should be observed if the triac is working.

Only test the triac for one protect cycle as prolonged testing will heat the triac to a high temperature.

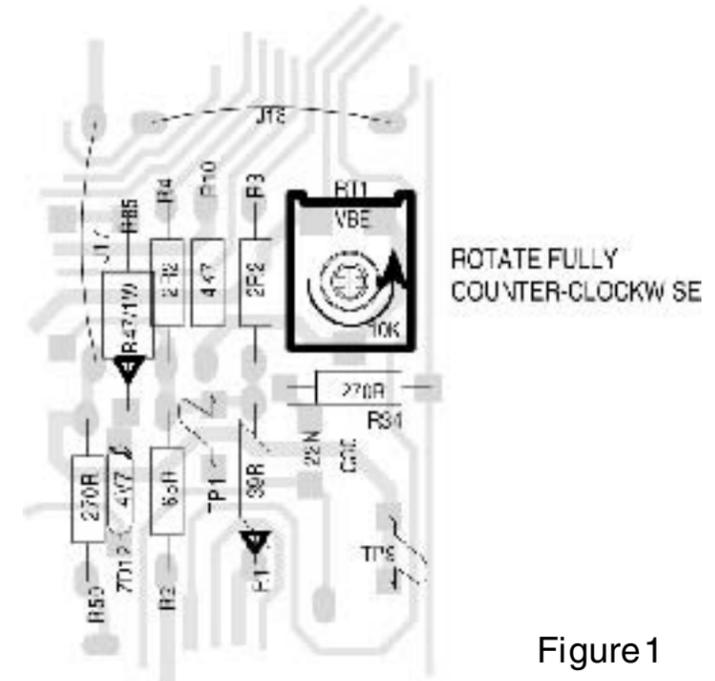
Figure 1

- STEP 1.** Locate the assembly drawing for the version number printed on the M1146 or M1126 circuit board to be serviced.
- STEP 2.** Remove all of the transistors coloured RED on the assembly drawing.
- STEP 3.** Measure and remove any of the diodes coloured BLUE on the assembly drawing that may be damaged. Replace a 1N4732A 1W 4V7 zener (#6459) ZD12 along with a series 0.5 ohm R85 resistor.
- STEP 4.** Rotate the trim pot RT1 fully counter - clockwise as in figure 1. Inspect and replace any resistors that look burnt. Measure all of the resistor values coloured YELLOW on the assembly drawing. The value that you measure may not be exactly what is shown on the assembly drawing but if the resistor doesn't look damaged it should measure within + or - 5% of the printed value.

- STEP 5.** Measure the resistor coloured GREEN. The measured value should measure within + or - 5% value listed in the table below. Replace any resistor that measured beyond the + or - 5% value listed in the table below.

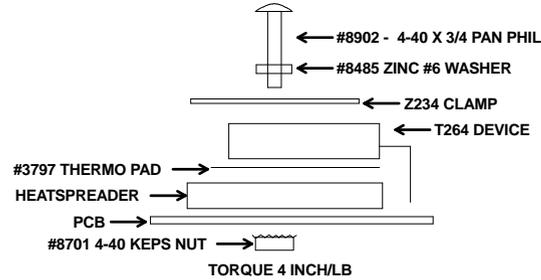
2. MOUNTING HARDWARE FOR Q5 AND Q6.

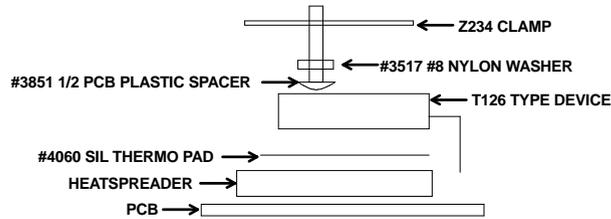
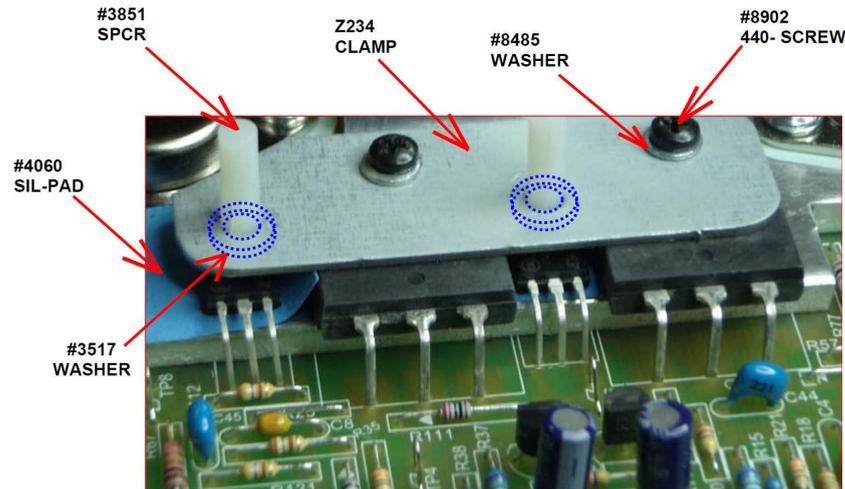
3. MOUNTING HARDWARE FOR Q40 AND Q41.

CLAMP DETAIL - SEE NOTES 2 AND 3.

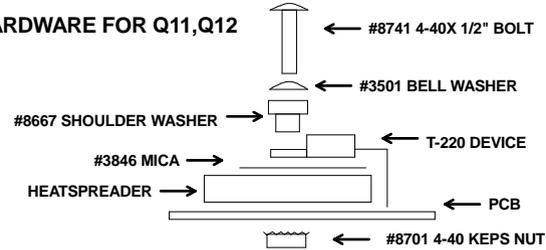
4. MOUNTING HARDWARE FOR Q11,Q12

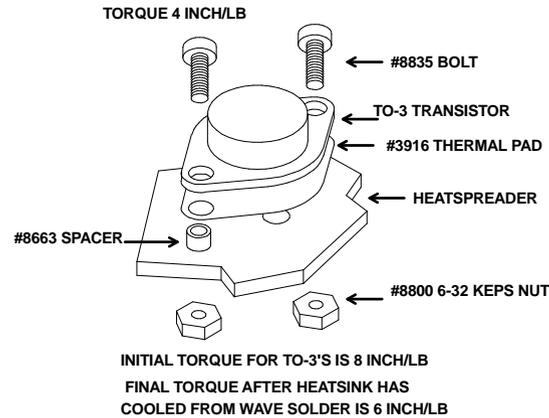
5. MOUNTING HARDWARE FOR TO3 OUTPUTS

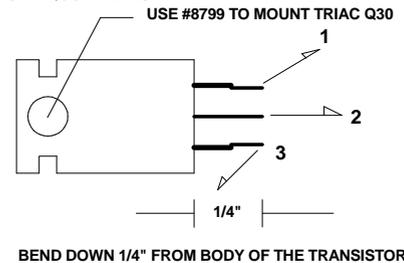
7. MOUNTING DETAILS FOR Q30 TRIAC

DO NOT CUT LEGS AFTER MOUNTING DEVICE. BEND LEGS AS PER DIRECTION OF THE BOTTOM PADS. IT IS IMPERATIVE THAT LEGS MARKED 2 AND 3 ARE BENT FLAT AGAINST THE BOTTOM COPPER SURFACE.

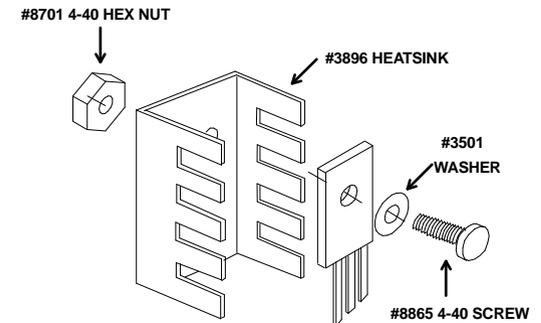
10. MOUNTING HARDWARE FOR Q15A AND Q16A.
